MISCELLANEOUS PAPER SL-79-18

6  
**NONDESTRUCTIVE TESTING OF CONCRETE  
T-WALLS, ATCHAFALAYA BASIN PROTECTION  
LEVEES, NEW ORLEANS DISTRICT**

10  
**Henry T. Thornton, Jr.**

14  
August 1979  
Final Report

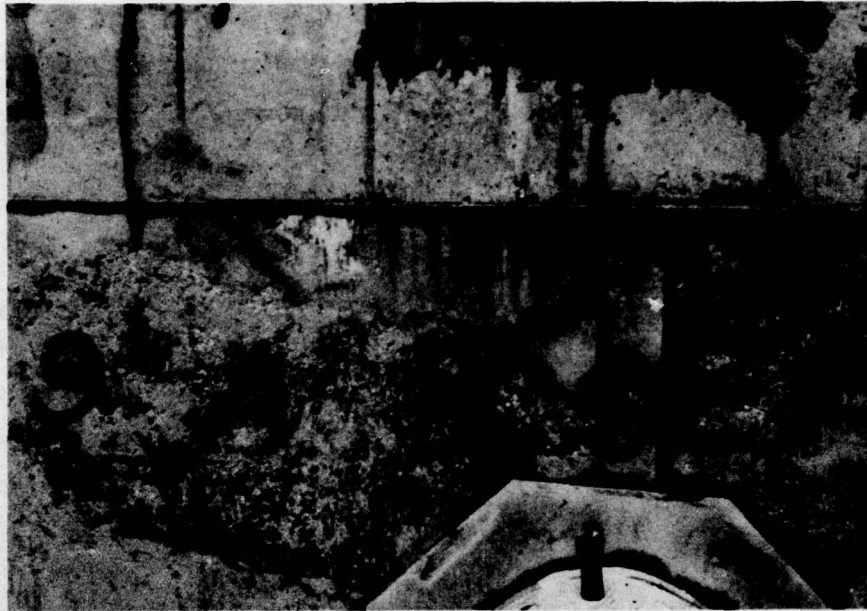
Velocities obtained at stations 3, 11, and 15 of groups 1 and 2 indicate areas of inferior quality concrete located along the visible seam in the west wall. The 11 measurements made along the base of the vertical wall (group 3) produced 1 velocity (station 11B) which is considerably lower than the others. This anomaly goes without explanation except for the possibility of incomplete consolidation. It is noted that station 11, which is directly above station 11B, also produced a low velocity. It is also noted that stations 9B and 10 are very near the lowest velocities in their respective groups, although they are within one standard deviation of their respective group means. The point is that these stations are all very close to that section of concrete which houses the casing collar (see Photo 7 and Figure 2). The additional steel reinforcing and irregular form shape could have contributed to incomplete consolidation in this area. Stations A through K were established to provide data in the allegedly patched and smoothed-over area in the west wall (see Photo 3 and Figure 2). As in the east wall, the velocities obtained from this group of stations generally confirm the presence of inferior quality concrete. The mean velocity for group 4 is 15 percent lower than the mean of groups 1-3 collectively.

Photo 5. Flood side, west T-wall

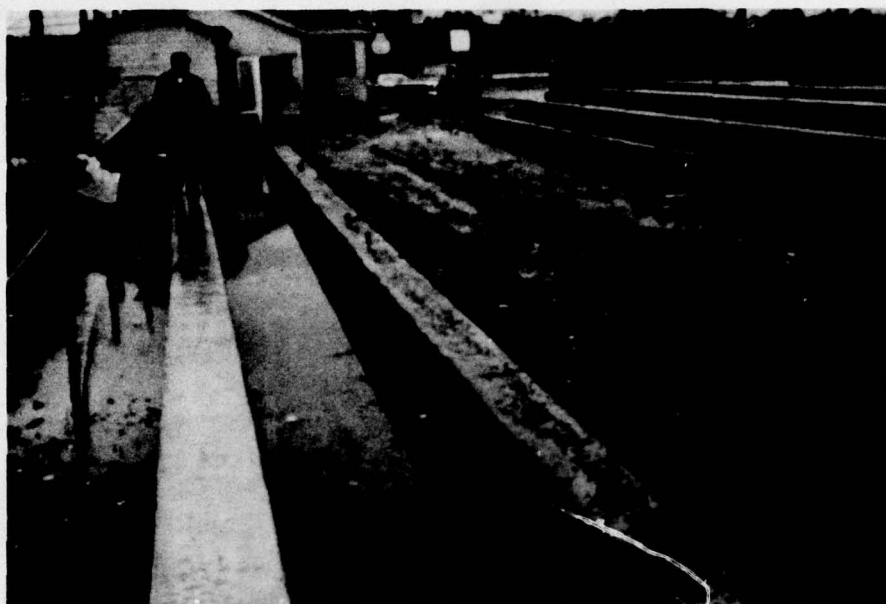
on companion piles which had not been driven. On 23 January 1979 Messrs. Henry Thornton and Michel Alexander travelled to the precast pile yard of Marine Concrete Structures, Inc., Metairie, La. Both shear mode and longitudinal mode pulse-echo measurements were made on cracked and uncracked piles. No difficulty was encountered in the measurements. Both shear and longitudinal echoes were received from the ends of the piles, and from the crack in the pile (see Photos 9 and 10). The results of these tests were considered to be excellent. With these results, and with expectations of having better access to the driven piles at the site, it was decided that there was at least an even chance for success. On 21 February 1979 Messrs. Thornton and Alexander returned to the east wall. More extensive excavation had been performed, but the exposed portions of the piles were still small (see Photo 11). After 2 days of intensive, exhaustive testing with no success the work was terminated. It was concluded that the damping factors of the surrounding soil and the 2.5-ft concrete cap were so high that the pile could not respond to the exciting impulse in either mode of test. An impulse of much higher energy than that available at the time would be required to excite piles in such an environment.

Photo 9. Companion pile, Metairie yard
